Manhole Inspection Summary

Manhole # S09MM1027MH

Location Address: **REAR 3520 MANCHESTER AVE** Cross Street: **BEAUFORD AVE**

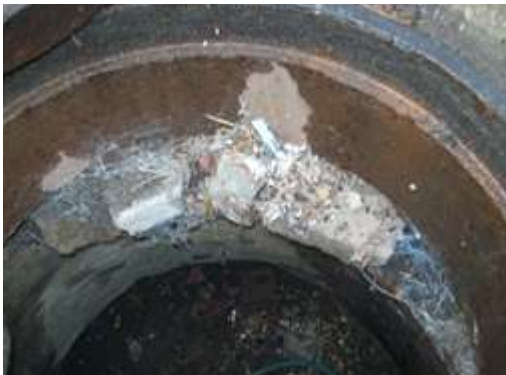
Defect 3

Condition: ☐ Sound ☐ Cracked ☐ Root Intrusion ☒ **Loose Brick** ☒ **Deteriorated**

LOOSE BRICK @ FRAME
ADJUSTMENT

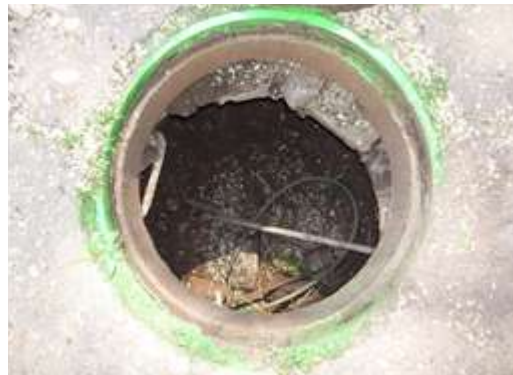
Defect 2

Frame Offset: **4** (in.) Condition: ☒ Sound ☐ Cracked ☐ Leaks

FRAME OFFSET

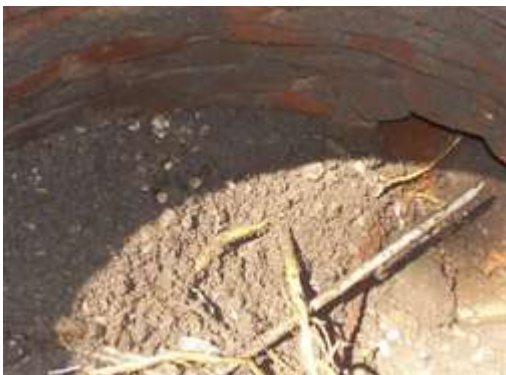
Defect 1

Condition: ☐ Sound ☐ Cracked ☒ **Root Intrusion** ☐ Deteriorated ☐ Leaks ☒ **Debris**

ROOT INTRUSION IN CHANNEL-
MEDIUM

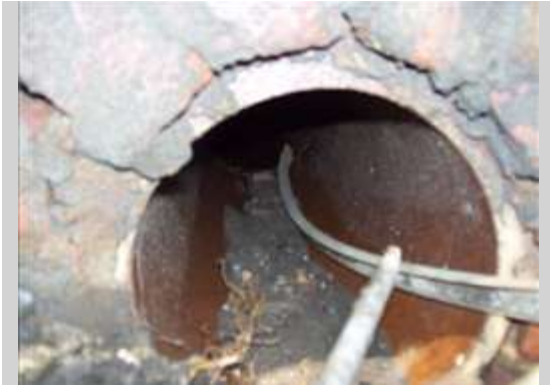
12 O'Clock Outflow

8 in. Circular Gravity Sewer
Pipe Out @ 12 O'Clock

Deposits: ☐ None ☐ Mud ☐ Sludge ☒ **Debris** ☐ Grease

Silt Depth: **0.5** (in.) Deposits Extent: **Light**
